## **Summary of Findings and Recommendations High Knob Brook Culverts – Starksboro, Vermont**

**Prepared by Milone & MacBroom, Inc.  
Revised March 29, 2010**

**Evaluation of High Knob Brook Culverts**

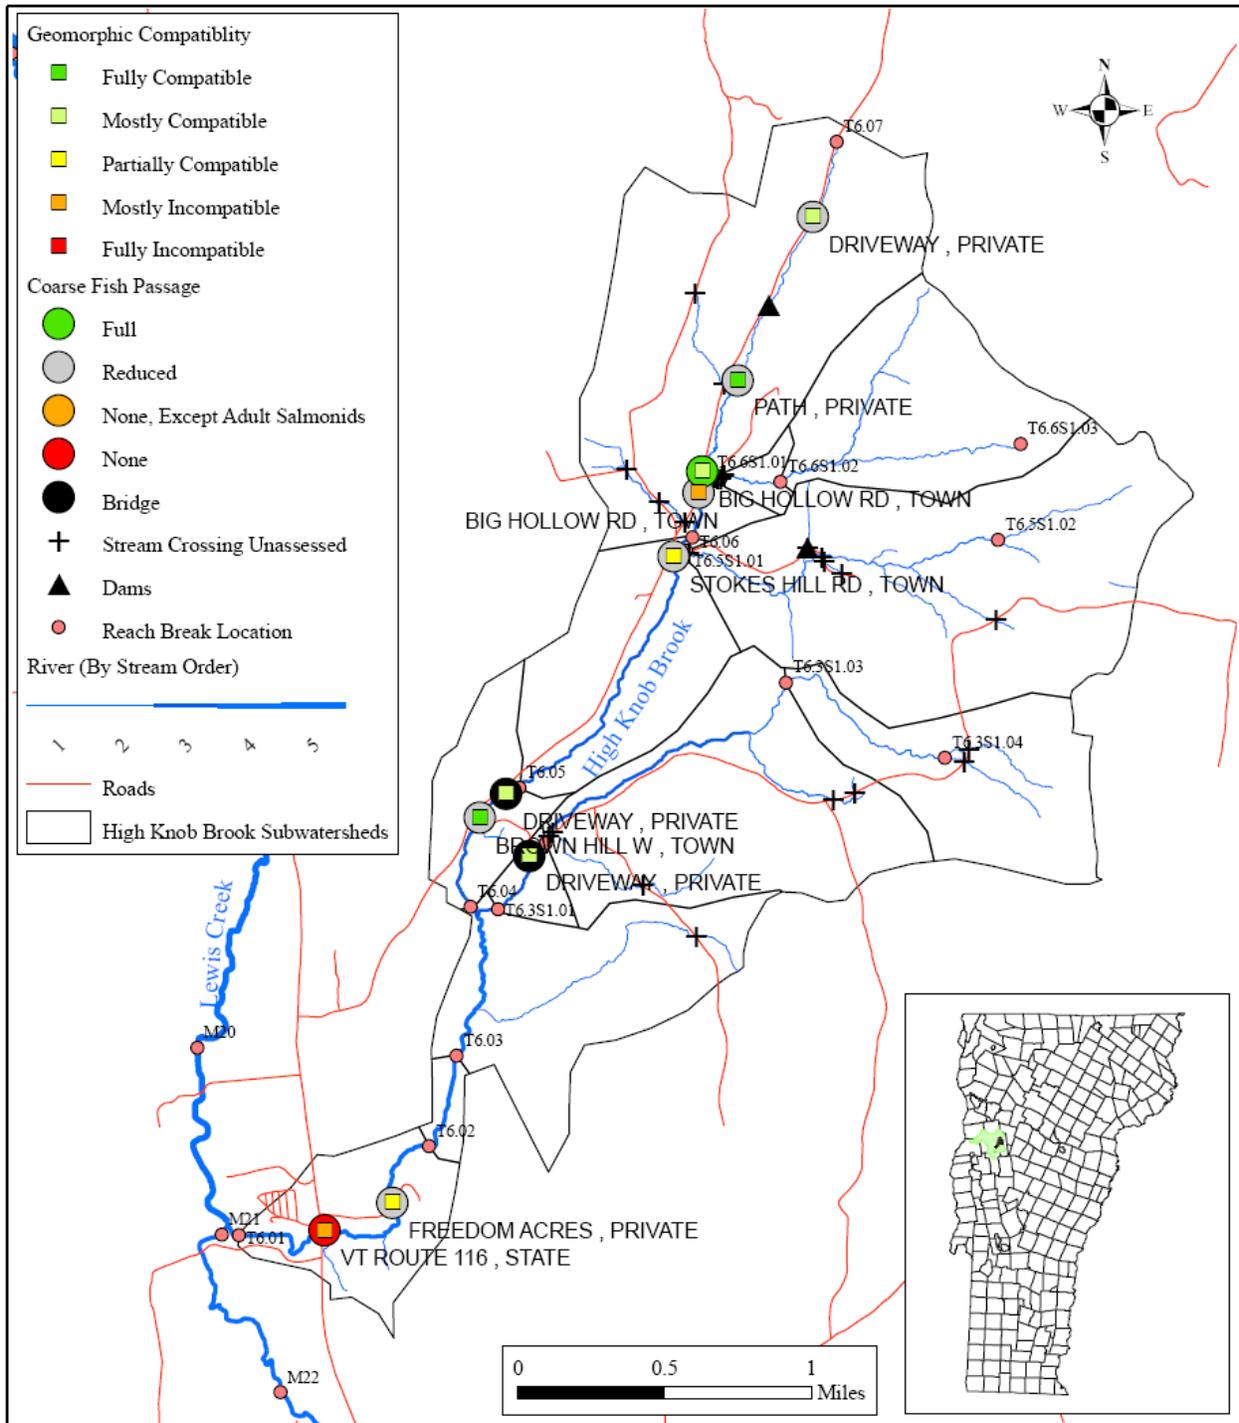
FIGURE 1: HIGH KNOB BROOK BRIDGE AND CULVERT ASSESSMENT DATA

Geomorphic assessment of High Knob Brook sponsored by Lewis Creek Association and performed by Milone & MacBroom in summer 2008 suggests that several culverts may have reduced geomorphic compatibility and are likely limiting movement of fish and wildlife (Figure 1). On-going watershed management planning performed by South Mountain Research & Consulting indicates that improvements at the four Town-owned culverts are a high priority for replacement in the future.

Many culverts, especially the smaller ones in headwater locations, are not assessed. More structures tend to be on small streams (order < 3) than on larger streams (order > 3) (Table 4, Figure 1). These small structures that often are most numerous in a watershed warrant assessment to understand both how upstream geomorphic processes and headwater habitat are being impacted. Upstream locations are critical for channel formation, sediment and woody debris supply, water quality establishment, and fish spawning. Failures of small headwater culverts can lead to downstream flood and erosion damages as pulses of water, sediment, and debris are sent downstream during floods. Again, the more the structures match the geomorphic stream type the longer they will last and the better instream habitat will be. It is recommended that an assessment of headwater culverts be performed to target problem structures for replacement.

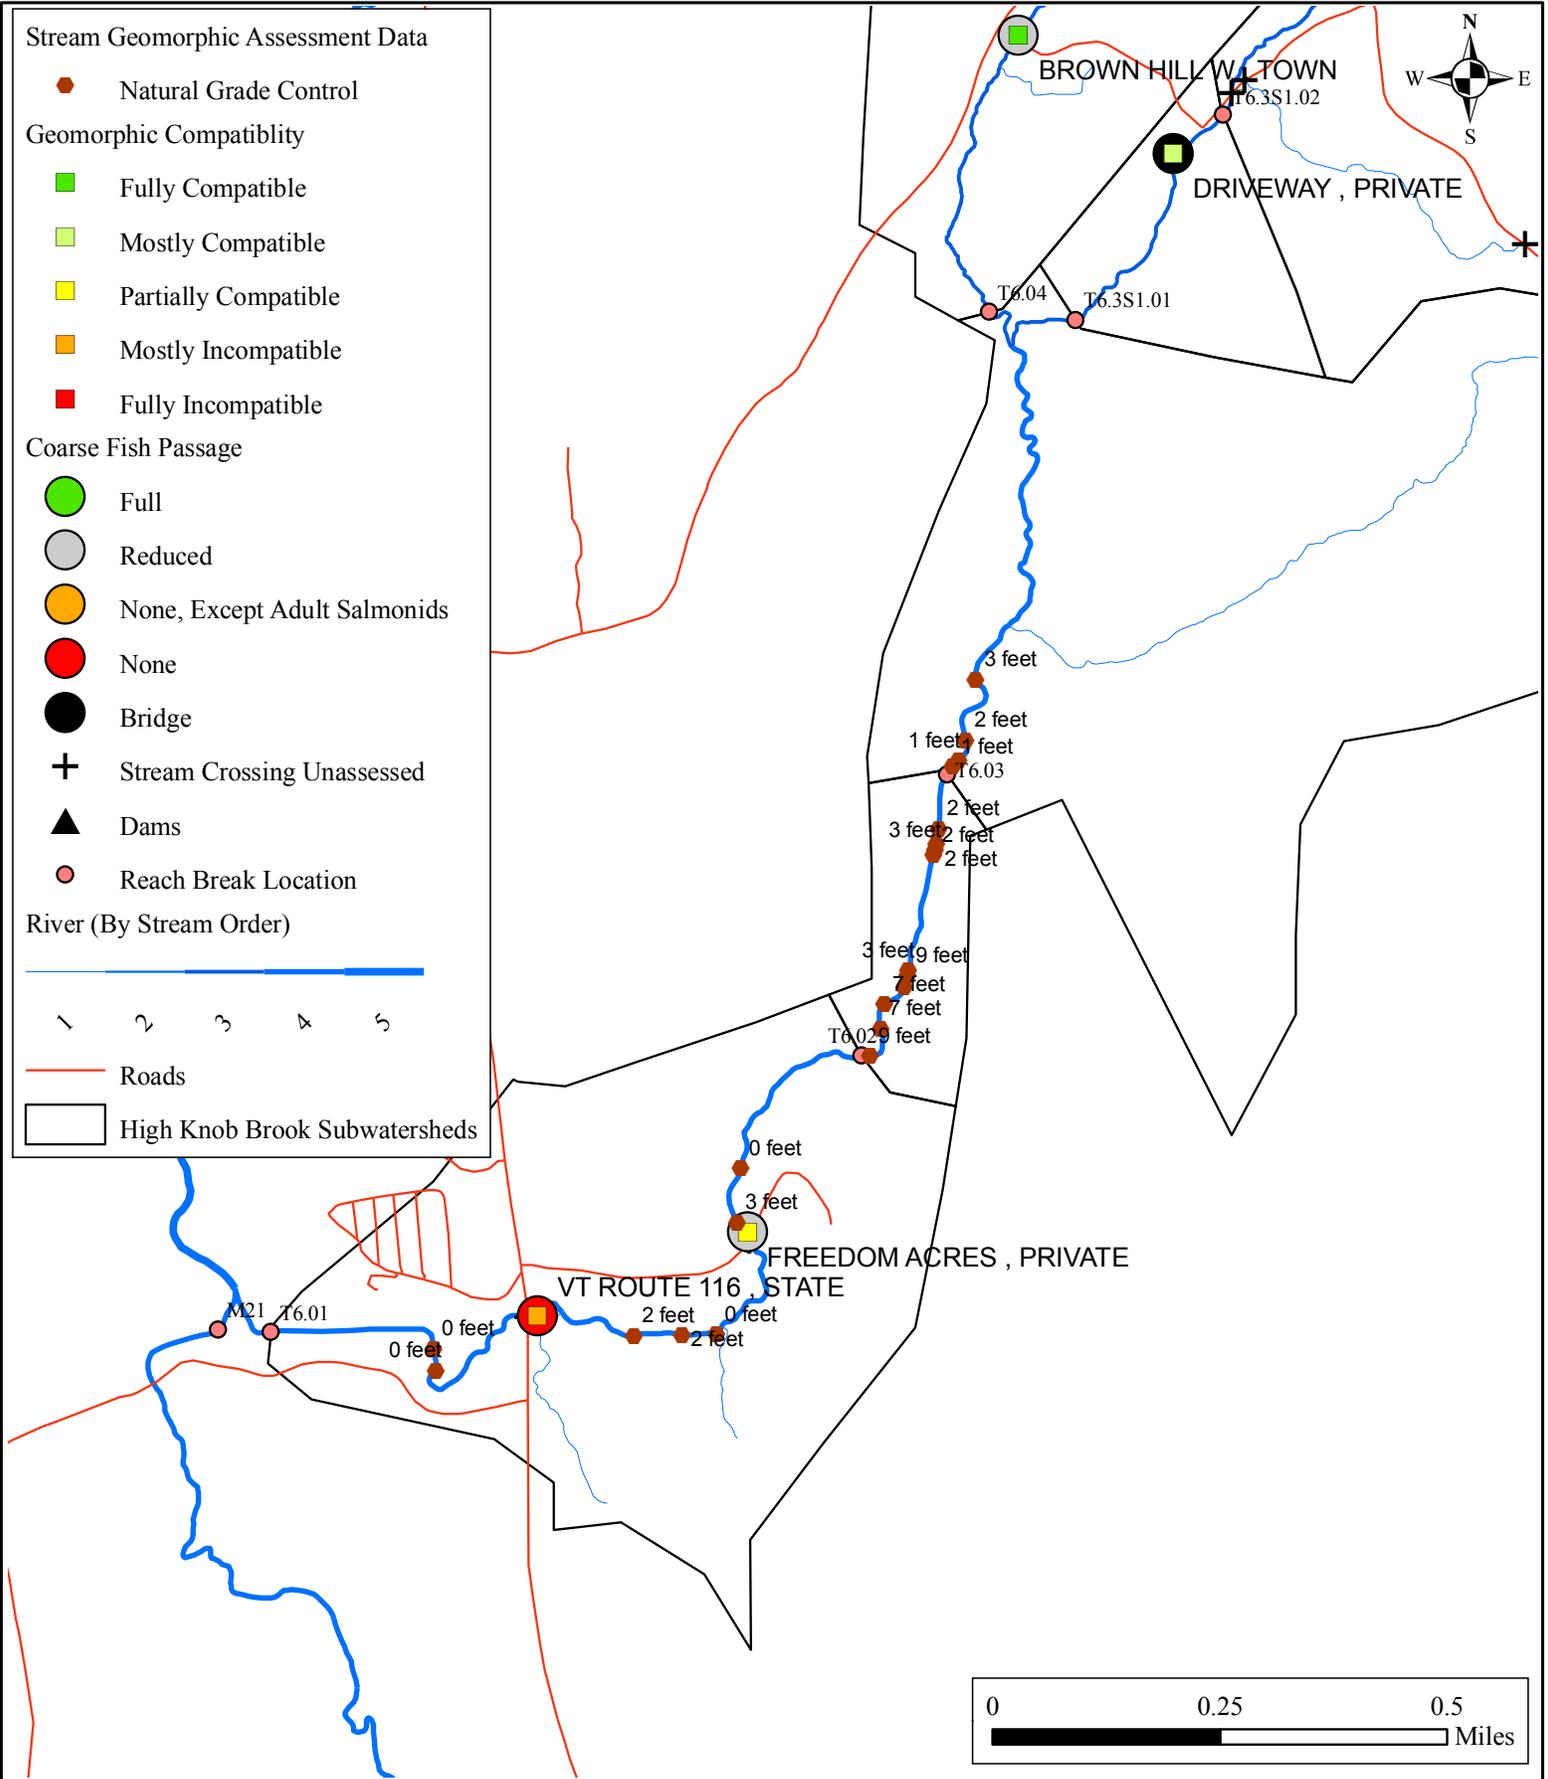
**SHEET:**  
Figure 2

**Crossing Structures and  
Natural Grade Controls**
