Appendix G Lowering Speed Limits

RE: Speed Limit Reduction request for VT 22A in Orwell

**Road Safety Audit Review
VT 22 A @ VT 73
Orwell**

VT 22A @ VT 73, Orwell Road Safety Audit Review Review Report

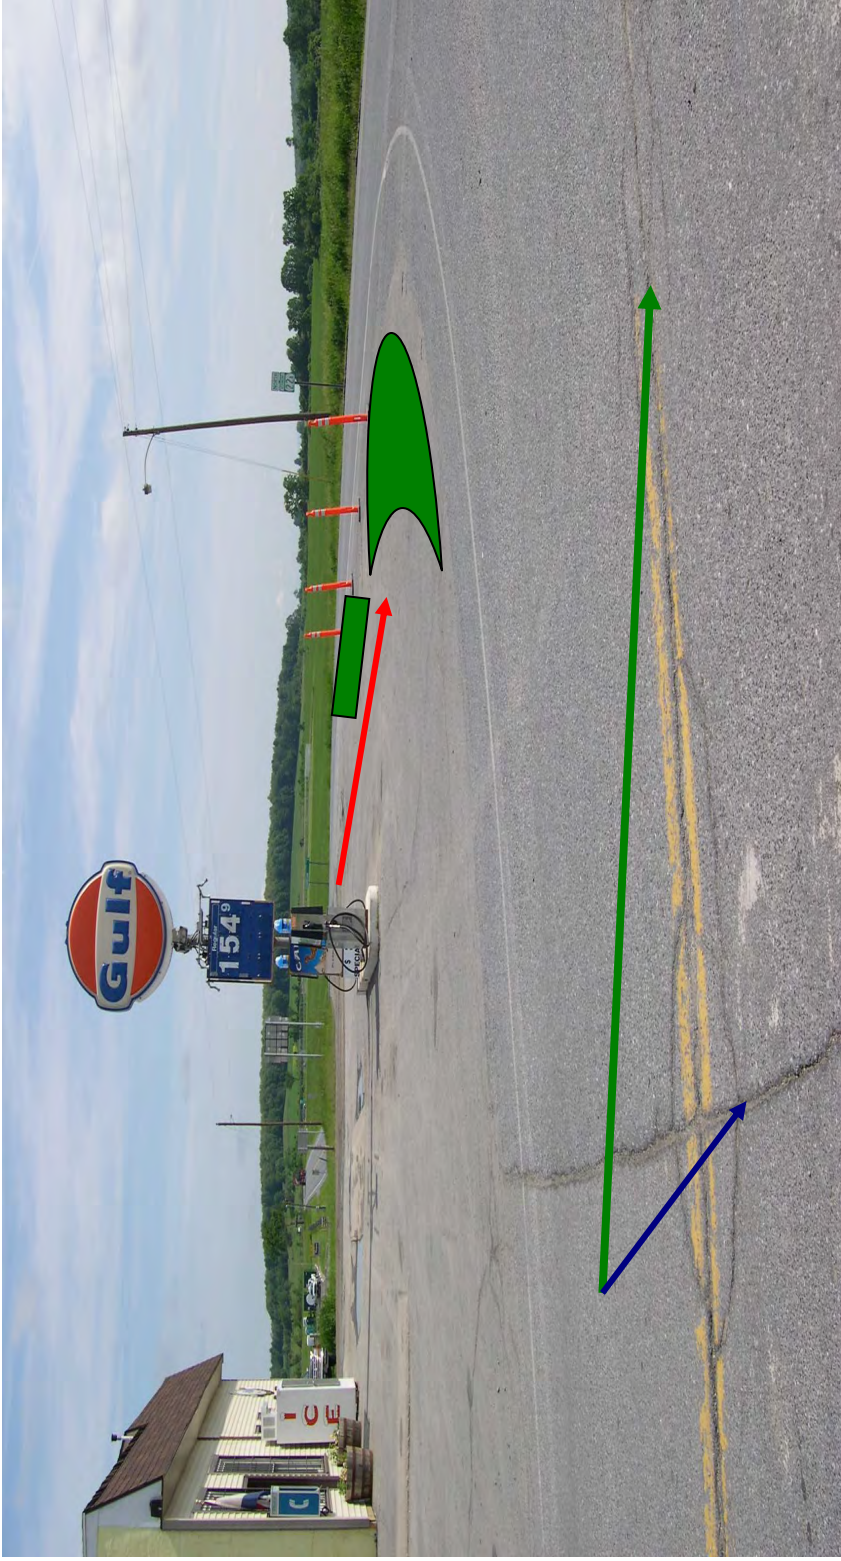
VT 22A North @ VT 73 State Numbered Town highway

1. The red arrows show the parking problem at the Gulf Gas Station. Installation of a raised island can solve the problem.
2. The blue arrow shows the Stop Bar current condition and the green arrow shows where it should be moved to get better sight distance.

1. Relocate the Stop Bars 4 ft from the edge of the pavement on VT 73 E and VT 73 Town Highway.
2. Upgrading the STOP sign on VT 73 W.
3. Replacing flashing beacon heads to LED's.
4. Installing delineators at the corner of VT 22A North and VT 73 East.
5. Talk to the owner of the gas station and the DTA about installing a raised island at the Gulf gas station.

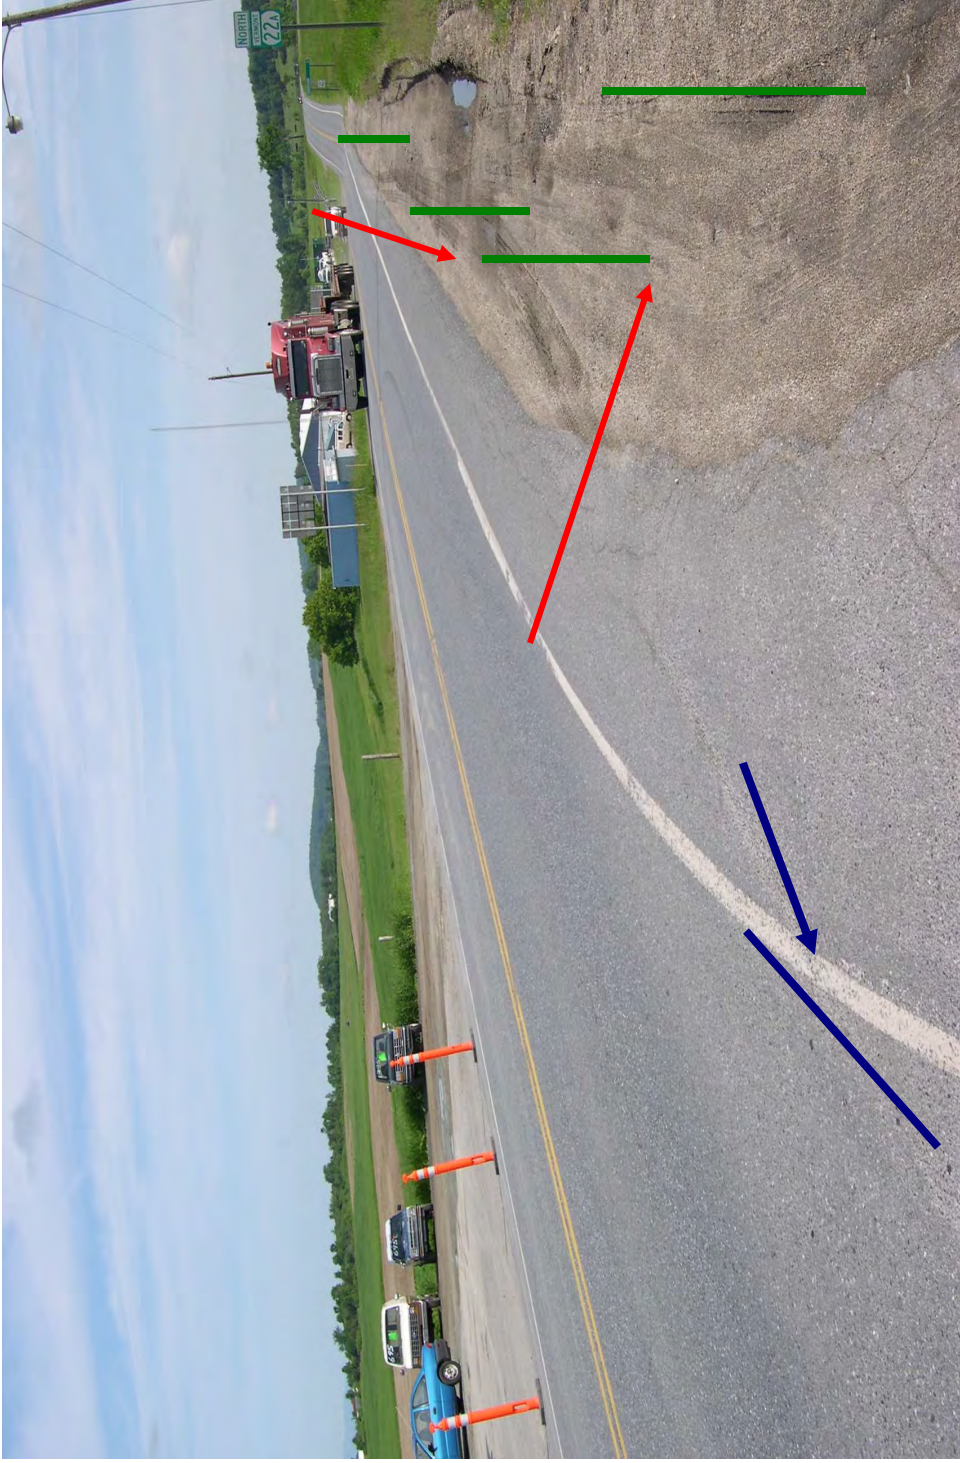
VT 22A North

- 1. The red arrows shows the area where trucks park at the edge of pavement and the green lines show that the installation of delineators could stop trucks parking there.**
- 2. The blue arrow shows that the turning radius should be changed.**
