Traffic Safety Section
Highway Safety Improvement Program
Location Review

Town: New Haven HSIP No.: 10-009
Route: US 7 @ FAS 183, River Rd Mile point: 0.55 (US 7), 0 (FAS 183)
Reviewed By: Mario Dupigny –Giroux Date Reviewed: _____

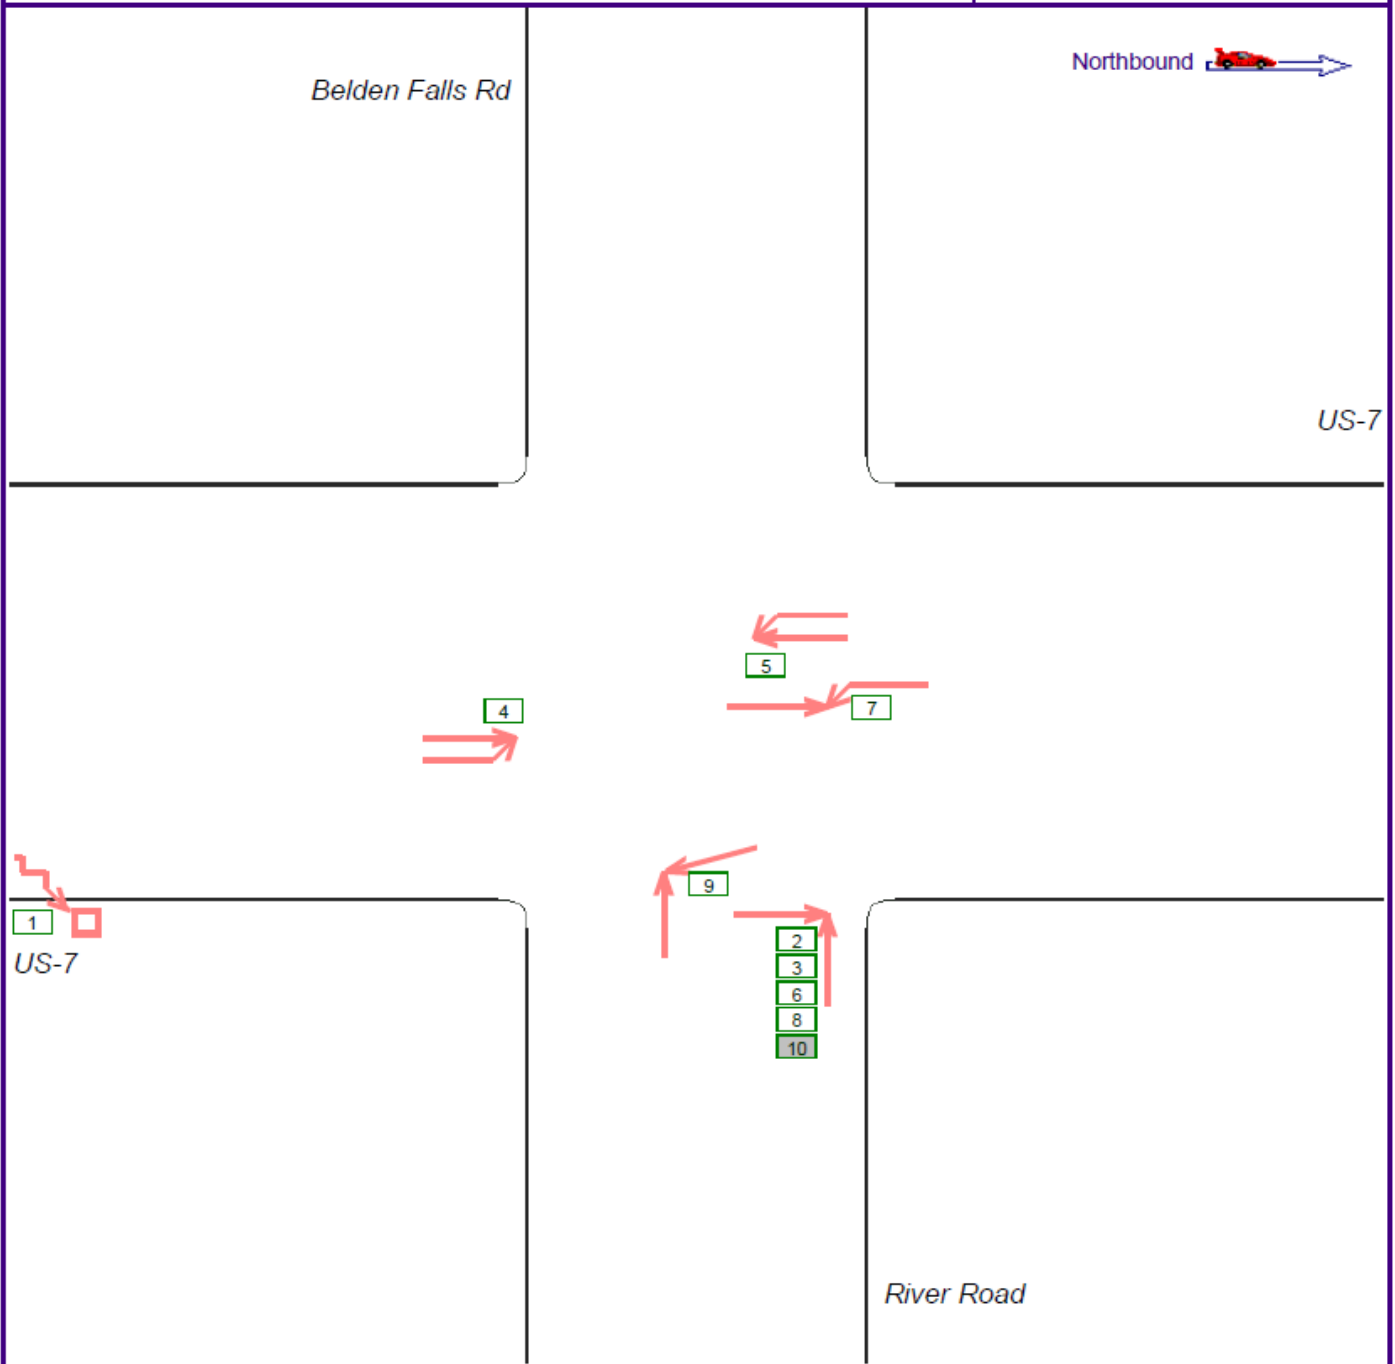
COLLISION DIAGRAM

There were ten crashes at this intersection between 2007 and 2009. The main crash pattern at this intersection (5 crashes out of 10) is a vehicle waiting on River Rd to make a left turn onto US 7 and colliding with a northbound vehicle. In three of the five crashes, there were northbound vehicles turning right onto River Road and the operator on River Road said that he/she did not see any more cars behind the last turning vehicle.

Crash Number	Road	Marker	Date	Time	Weather	Injuries	Fatalities	Type	Description
1	US-7	0.52	2/10/2009	14:48	Cloudy	0	0	Single Vehicle Crash	Cloudy. The paved surface of US 7 was clear and dry . Op #1 advised he was traveling NB on US 7 when he observed something run out in front of him . He stated he swerved to avoid the animal and went off the road . Witness #1 advised she was traveling behind the operator and observed nothing run out in front of him and it appeared he merely drifted off the road, as if he had fallen asleep or something. There were no skid or scuff marks in the roadway to cooperate Op#1's story and there were no animal tracks found in the snow on either side of the road to confirm the operators story. V 1, M 68. Inj 5.
2	US-7	0.55	8/7/2007	7:38	Clear	0	0	No Turns, Thru moves only, Broadside	Clear. Surface was dry . 1 had come to a stop, started to drive slowly to see if it was clear to pull onto US 7 . Said saw 2 from south coming to a stop. 2 was nb when he saw 1 starting to drive onto US 7, 2 slammed the breaks. V1 F 32 Inj 5, V2 M 50 Inj 5.

3	US-7	0.55	9/8/2007	13:45	Cloudy	0	0	Left Turn and Thru, Head On	1 was stopped on River Rd waiting to turn left onto US 7. A group of cars had slowed down and pulled to the right indicating that they were going to turn right onto River Rd. 1 said did not see any vehicles behind the group turning. 1 started to go and a nb vehicle appeared and she did not have enough time to stop. 2 said that was nb and that two or three vehicles were in front turning right. As he continued pass the vehicles, 1 pulled from River Rd. V1 F 31 Inj 5. V2 M 51 Inj 5. Cloudy and dry.
4	US-7	0.55	9/16/2007	15:55	Clear	3	0	Left Turn and Thru, Broadside	Dry and Clear. 1 was traveling north, had put on his left turn signal to turn left on Belden . Said that as he was turning, he was suddenly hit. 2 was nb following a vehicle that he thought was going to turn right onto River Rd. Said 1 pulled to the right and then turned to the left. V1 M 20 Inj 3, V2 M 37 Inj 5

5	US-7	0.55	8/8/2008	15:11	Rain	0	0	Same Direction Sideswipe	The road conditions on this day were dry. The weather was calm and partly cloudy . Veh 1 informed that he turned a left turn signal on and started to make a left turn onto River Road when he was struck by veh 2. V1 informed that V2 came around him on the driver's side and was, as he believes, attempting to overtake his vehicle. V2 was traveling southbound. Said was in the passing lane and was attempting to overtake V1, which was travel southbound in the travel lane. When V2 was almost beside V1, V1 turned right into his passenger side. V1, M 65. Inj 5. V2, M 46 Inj 5.
6	US-7	0.55	10/1/2008	7:45	Cloudy	2	0	No Turns, Thru moves only, Broadside	The weather was clear and the road dry . Operator #1 stated she was on River Road and came to a stop at the intersection with Route 7. She stated she saw a north bound vehicle turning onto River Road so she thought the way was clear . She did not see any other vehicles so she pulled out and hit the other vehicle. Operator #2 stated she was north bound when the other vehicle pulled right in front of her. Witness #2 stated he was northbound on Route 7 and was turning onto River Road. He stated that he went into the brake down lane to turn right when he saw a black vehicle coming off River Road onto Route 7. He stated that he knew there was another north bound vehicle behind his so hit his horn to try and warn the vehicle on River Road but the black vehicle pulled out and the cars hit. V1, F, 40, Inj 3. V2, F, 59, Inj 2.

7	US-7	0.55	11/24/2008	20:54	Cloudy	0	0	Left Turn and Thru, Angle Broadside	The weather was cloudy and cold and the road surface was clear and dry. V#1 was traveling south on US Route 7 when he signaled left and then slowed down to a stop to let NB traffic pass prior to turning. Op#1 then attempted to complete his left hand turn across US Route 7 onto River Road when he was struck by V#2. V#2 stated she was traveling north on US Route 7 at approximately 50 MPH. Op#2 advised out of nowhere V#1 pulled out in front of her, she attempted to swerve and avoid it, however still struck the rear bumper of V#1. V1 is male, 88, Injury 5. V2 is Female, 19, Injury 5.

8	US-7	0.56	9/7/2009	16:15	Clear	2	0	Left Turn and Thru, Broadside	Clear, road dry. Op #1 advised she was on River Rd. preparing to turn left. Op #1 advised she observed a van travelling north that had its turn signal on indicating it was going to be turning right on to River Rd. Op #1 advised she checked to the north and did not see any vehicles approaching and did not see any vehicles behind the van. Op #1 advised she pulled out onto Rte. 7 and a motorcycle suddenly appeared from behind the van. The back end of the motorcycle collided with her vehicle. Op#2 advised he was travelling north on US 7 following a van. He advised that the van had turned on its directional signal to make a right turn. Op #2 as the van turned right onto a side road he continued by when a vehicle suddenly pulled off a side road directly in front of him. Op #2 applied his brakes and attempted to stop. Witn #1 was in a van nb 7. Advised he was turning right onto River Rd. and a vehicle that had been waiting at the end River Rd. began to pull out onto US 7. Advised that a moto had been behind him and when Veh1 on River Rd. pulled out, it did so directly in front of the moto. V1 F 34, Inj 3. V2, M 47, Inj 3

9	US-7	0.56	11/23/2009	15:21	Cloudy	0	0	Right Turn and Thru, Head On	Weather was cloudy and the surface of the road was dry and had a light covering of rocks/sand on the pavement. Witn1 witnessed the crash from a position parked behind V#2. Advised that V#1 came around the corner from northbound and turning eastbound on River Rd and was going too fast. While making the turn the vehicle slid around the corner and struck V#2 which was stopped waiting to make a turn from River Road onto US 7. Op#2 was stopped at the stop bar on River Road waiting to make a turn when she saw V #1 hitting her as he turned the corner. Op#1 advised that he didn't realize the turn was coming up on him as fast as it did. In attempting to make the corner, he slid a small amount on the sand and gravel and struck Vehicle #2. While investigating the scene I observed skid marks in the sandy portion of the roadway. V1 M 36, Inj 5. V2 F 21, Inj 5.

10	US-7	0.56	12/2/2009	6:10	Cloudy	1	1	No Turns, Thru moves only, Broadside	It was dark, cold and cloudy and the road surface was clear and dry . Op#2 was traveling nb at 50mph. Saw Veh#1 stopped at the intersection of River Road. Saw Veh#1 pull out and start to turn left in front of him. Witn1 was traveling nb directly behind Veh#2. Advised that as they approached the intersection, Veh#1 just pulled out in front of Veh#2 and they collided in the intersection. Witn2 was traveling west on River Road directly behind Vehicle #1. He advised that as they approached the intersection, Veh#1 stopped briefly and then just pulled out into the intersection and the collision occurred. Veh 1, M 85, Inj 1. Veh 2, M 51, Inj 3.
----	------	------	-----------	------	--------	---	---	--	---
