Traffic Safety Section
Highway Safety Improvement Program
Location Review

Town: Salisbury HSIP No.: 10-033
Route: FAS 0175 Lake Dunmore Rd Mile point: 2.540 – 2.840
Reviewed By: Mario Dupigny-Giroux Date Reviewed: _____

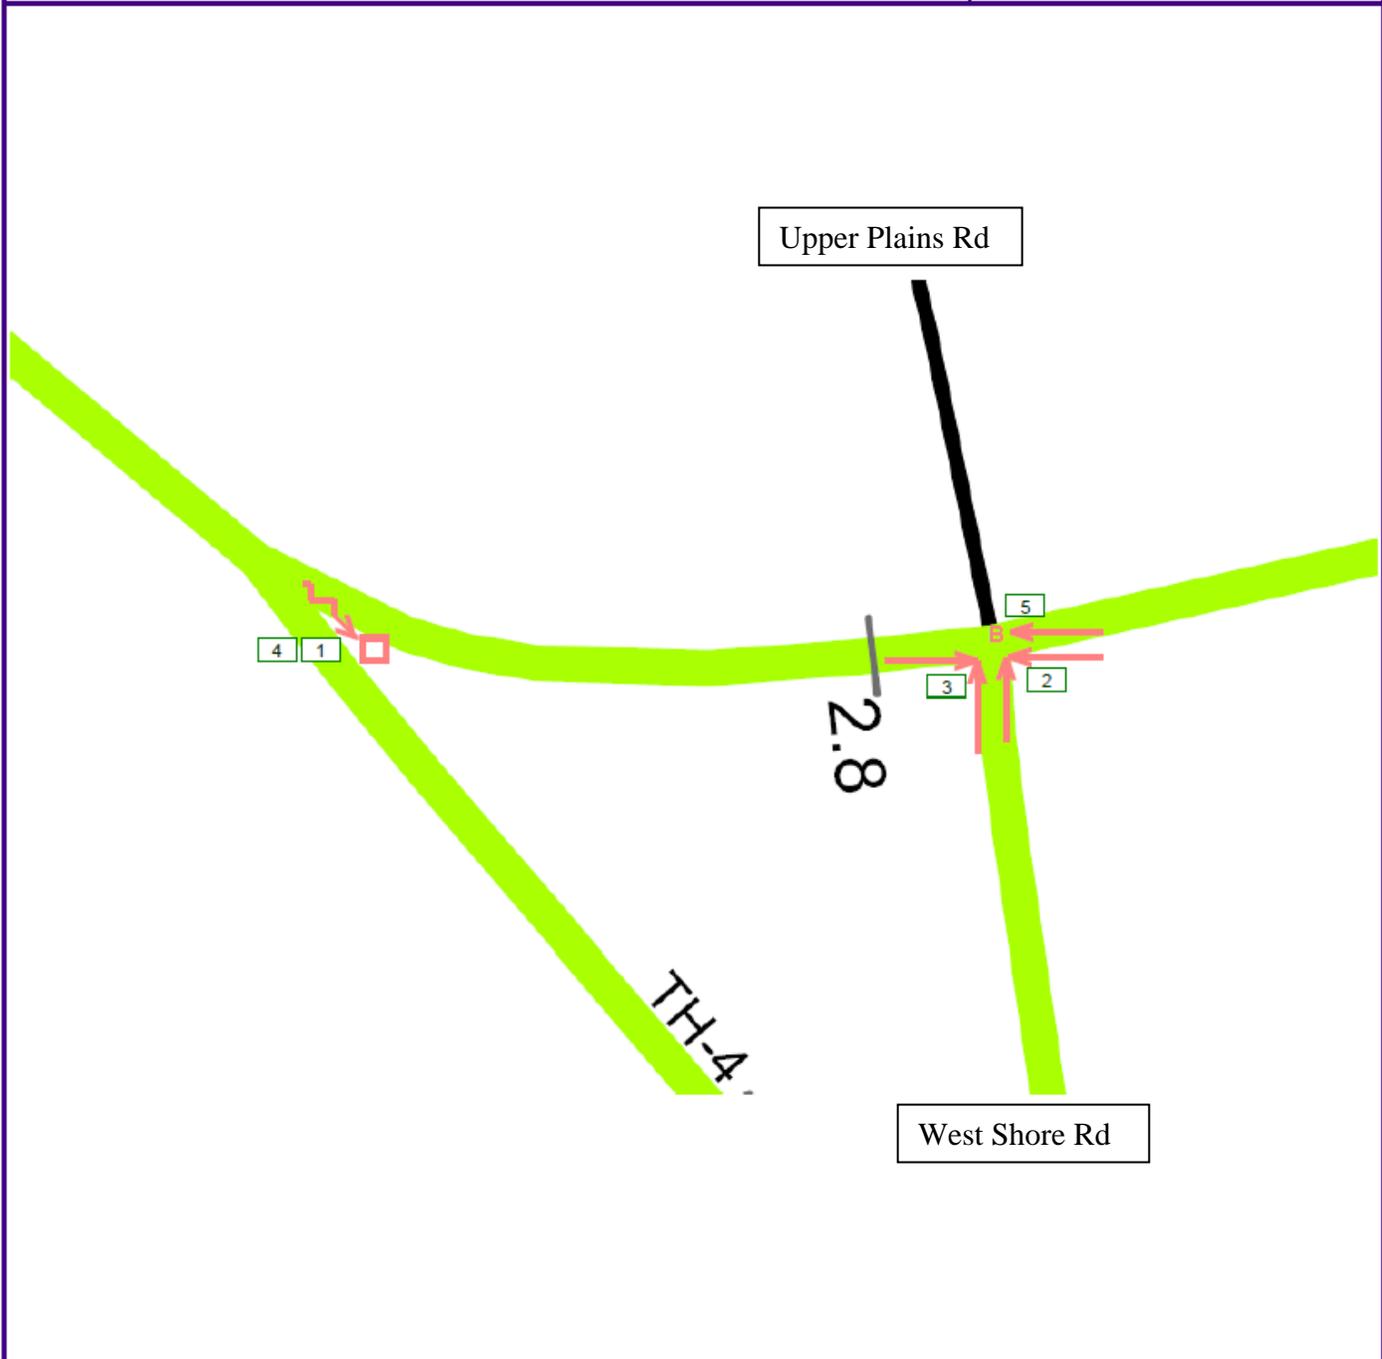
COLLISION DIAGRAM

There were five crashes along this segment between 2007 and 2009. Two locations stood out: The four-way intersection at mile point 2.79 with three right angle crashes and where Rte 53 splits at mile point 2.85 with two run off the road crashes.

At the four-way intersection, all three crashes involved a vehicle coming from West Shore Rd who failed to yield to Rte 53 traffic. In some cases, witnesses to the crashes said that the vehicles did not stop and entered the intersection.

Field Work: Check the corner sight distance to the right of West Shore Rd.

Stop bars?
