Road Safety Audit Review
Burpee Road @ Plank Road
Town of Bristol
July 2, 2008

Burpee Road @ Plank Road

Road Safety Audit Review

Review Report

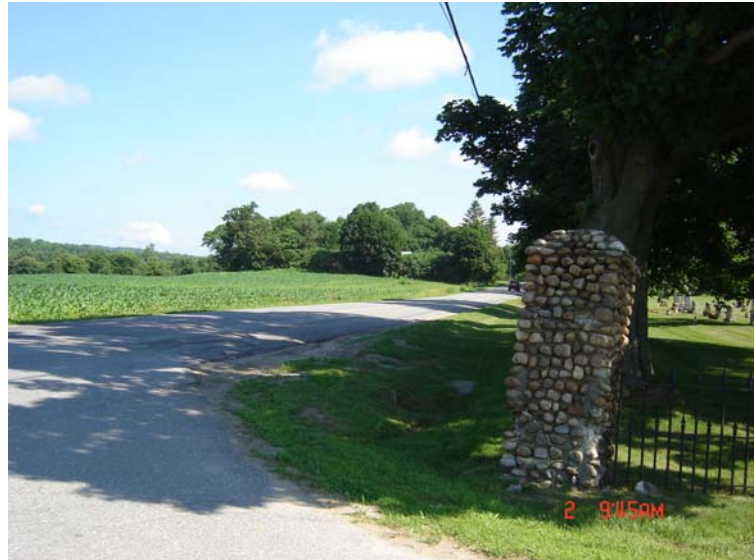
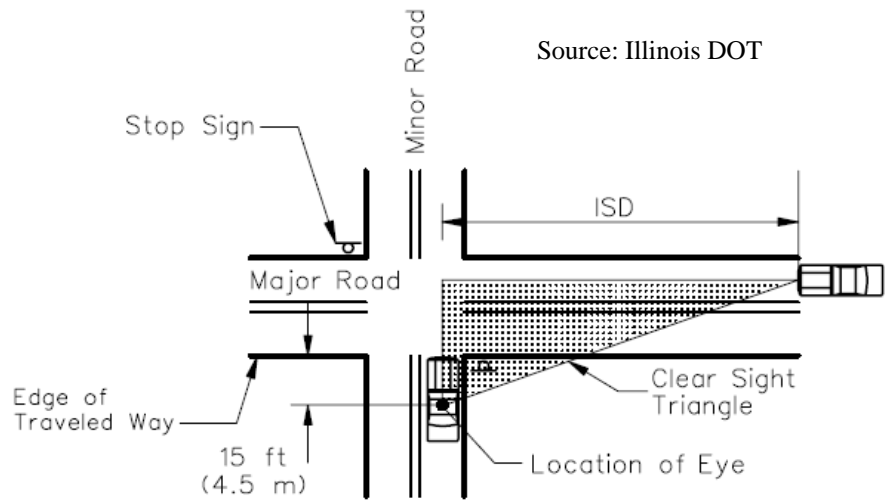
Problem:

Limited corner sight distance to the north when stopped on the east side of Plank Road

Immediate Actions:

Install a 24" stop bar four feet from the edge of Burpee Road

Short Term:

Promote a clear sight triangle as recommended by AASHTO

From the edge of the road, measure 15 ft back (this is the vertex of the sight triangle)

For an estimated traveling speed of 50 mph, "ISD" is 555 ft

For an estimated traveling speed of 40 mph, "ISD" is 445 ft

Anything within the triangle area such defined should be as much as possible removed

Work with the cemetery to have the stone pillar removed or relocated as it is an obstruction

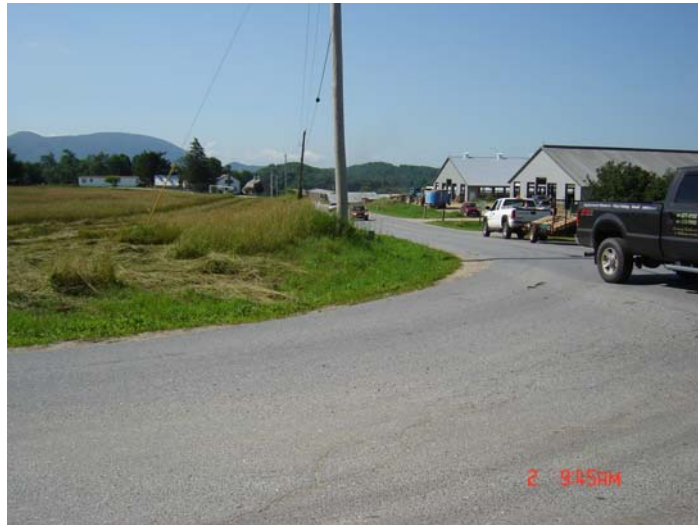
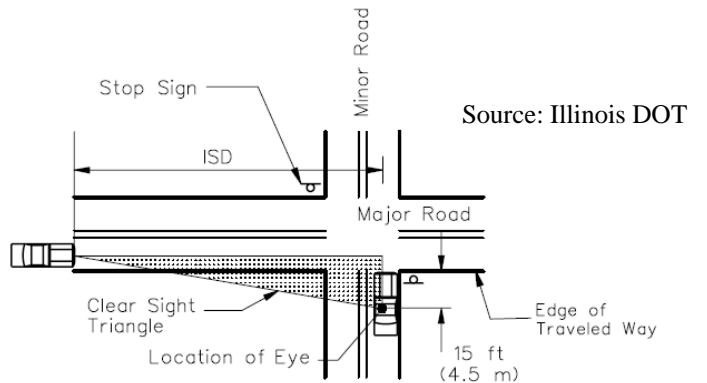
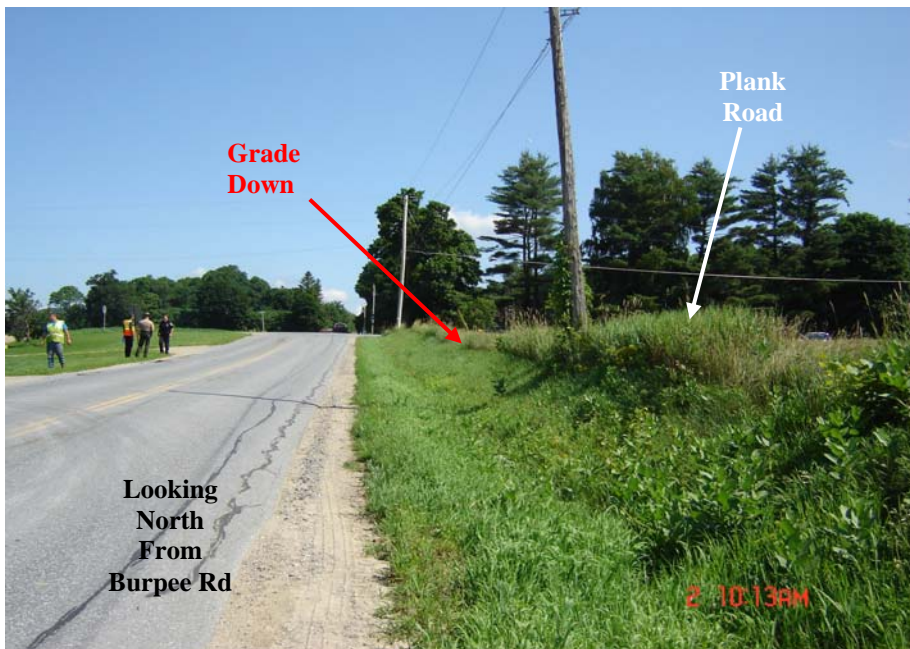
Problem:

Limited corner sight distance to the south when stopped on the west side of Plank Road

The utility pole is an obstruction. Work with the utility company to have it relocated

Short Term:

Define the sight triangle as previously explained

Grade down the berm

Work with the farmer to ensure that grass in the southeast corner is kept low

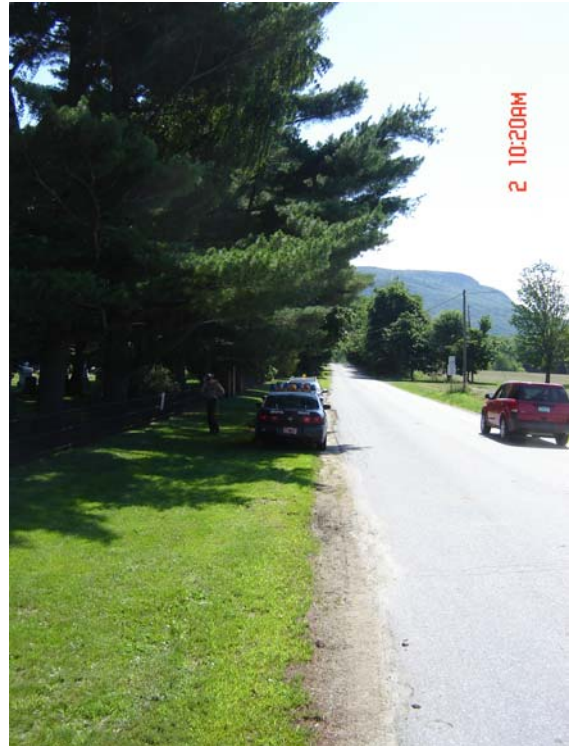
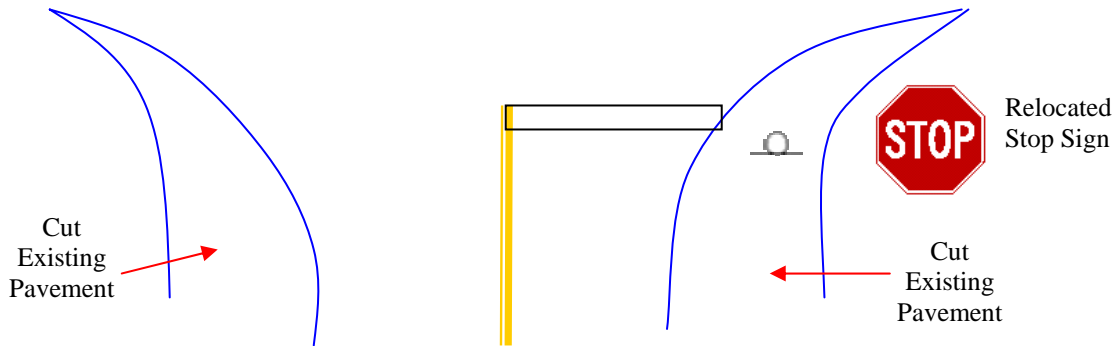
Problem:

Lack of definition of the Plank Road approach (east side)

Immediate Actions:

Install a 30" x 30" stop ahead sign (W3-1) in advance of the intersection

Short Term:

Narrow down the approach by removing some pavement on the corners and creating appropriate radii for trucks

Move up the stop sign (replace with new 30" x 30" R1-1) closer to the intersection in the area where pavement was removed

Installed about 30 ft of double yellow centerline

Install a stop bar four feet from

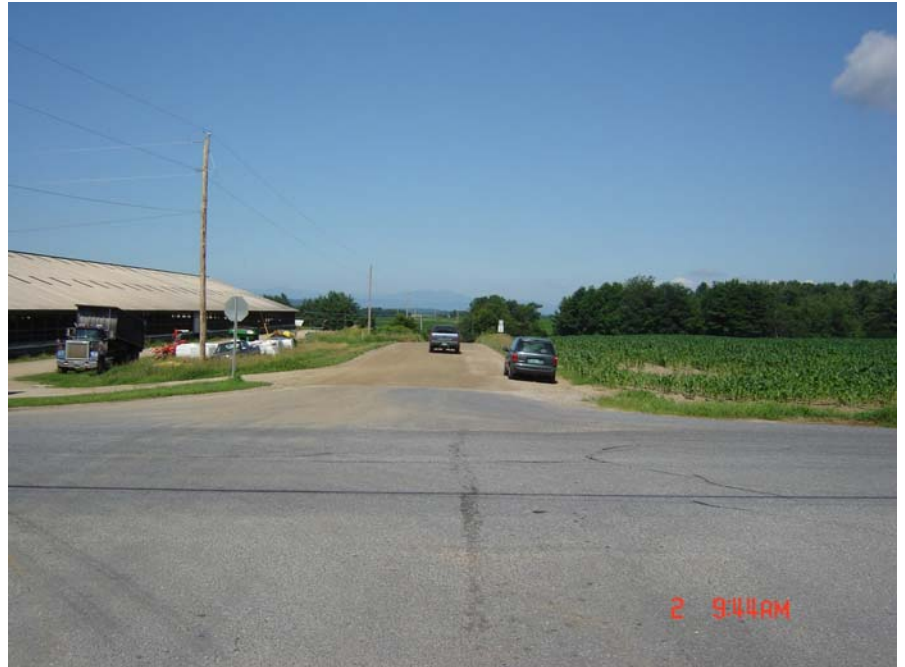
Problem:

Lack of definition of the Plank Road approach (west side)

Immediate Actions:

Install a 30" x 30" stop ahead sign (W3-1) in advance of the intersection

Short Term:

Reduce the width of the road to a 24 ft profile

Narrow down the approach by removing some pavement on the corners and creating appropriate radii for trucks

Move up the stop sign (replace with new 30" x 30" R1-1) closer to the intersection in the area where pavement was removed

Installed about 30 ft of double yellow centerline

Install a stop bar four feet from the edge of Burpee Road

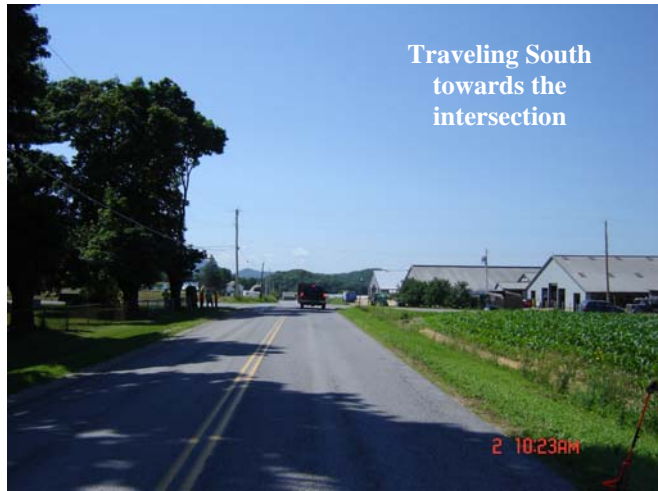
Problem:

Lack of conspicuity of the intersection when traveling on Burpee Road

Traveling South towards the intersection

Immediate Actions:

Replace the existing street name signs with new 9-inch blade ones (6-inch letters, D3-1)

In both directions, add a 36" x 36" four-way intersection sign (W2-1) with a Plank Road street name plaque underneath (W16-8). Use type IX fluorescent yellow sheeting. Install on two posts

Short Term:

Work with the cemetery to have the lower tree limbs pruned

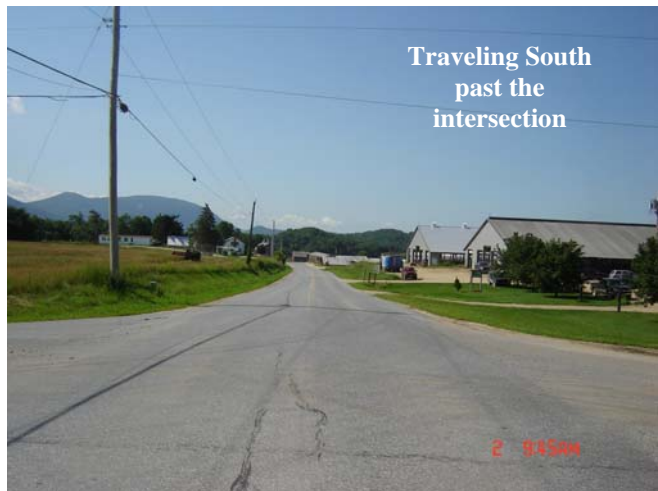
Traveling South past the intersection

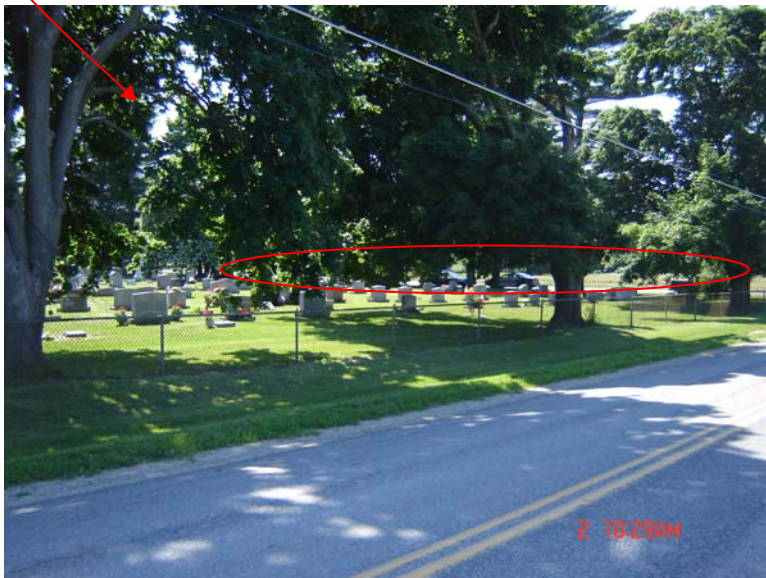
Problem:

Perceived high approaching speeds on Burpee Road

Note:

The intersection warning signs suggested above will help with this issue

Short Term:

Install white edgelines on both sides of Burpee Road in both directions

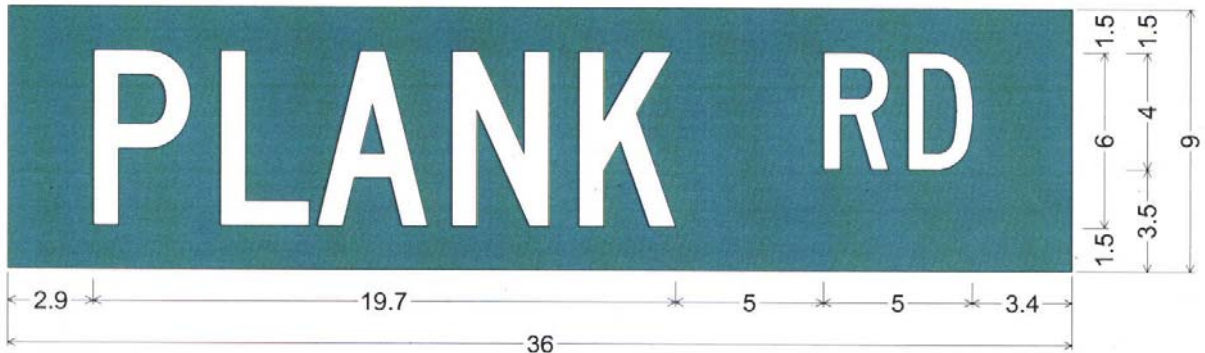
D3-1, 9-inch Plank Road Street Name Sign

D-3; No border, White on Green;
"PLANK" C 80% spacing; "RD" C 80% spacing;

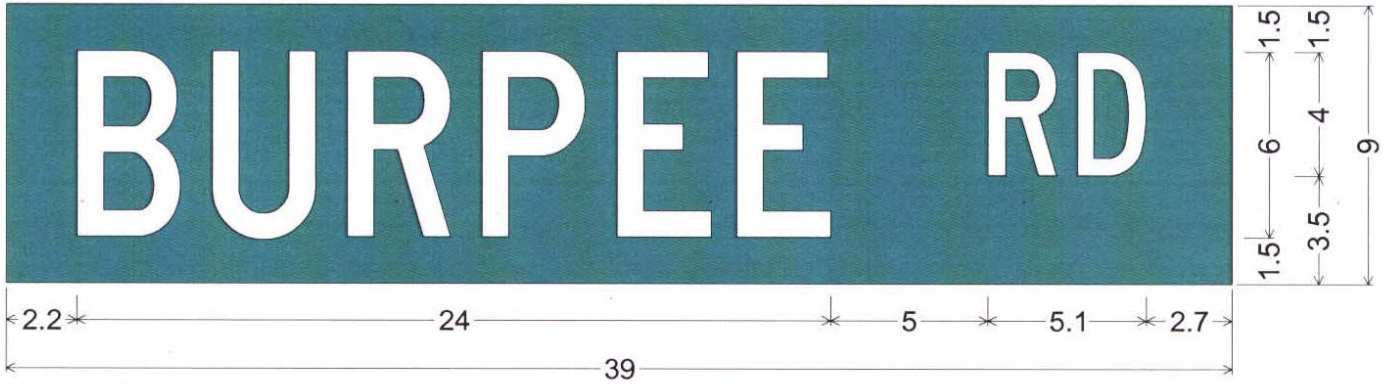
D3-1, 9-inch Burpee Road Street Name Sign

D-3; No border, White on Green;
"BURPEE" C 80% spacing; "RD" C 80% spacing;

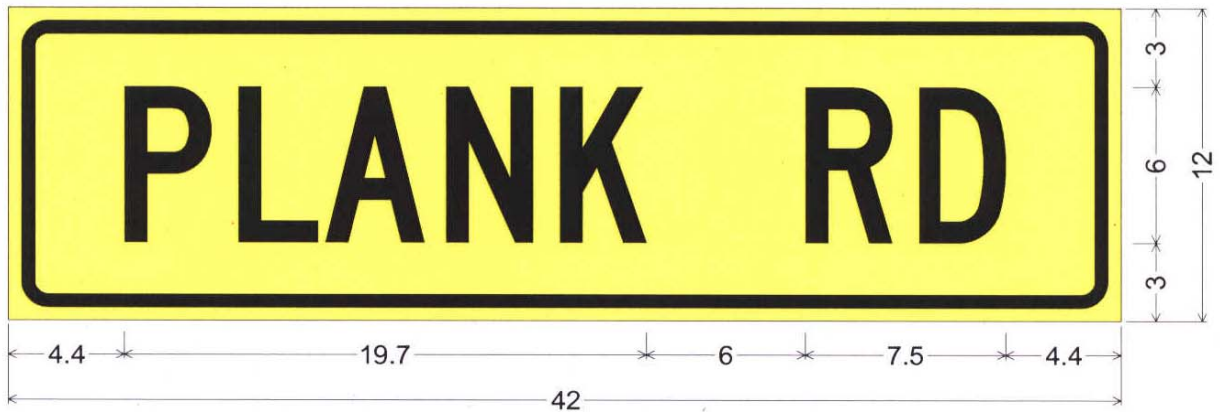
W16-1, Plank Road Supplemental Name Plaque

1.5" Radius, 0.5" Border, 0.5" Indent, Black on Yellow;
"PLANK RD" C 80% spacing;

Note: Use Type IX Fluorescent Yellow Sheeting
