## Road Safety Audit Review

<b>Town:</b>	Leicester	<b>Date Reviewed:</b>	July 8, 2014
<b>Route:</b>	Leicester Whiting Road @ Old Jerusalem	<b>Mile points:</b>

The location of this RSAR is the intersection of Leicester-Whiting Road and Old Jerusalem Road in Leicester.

This RSAR was conducted at the request of the Addison County Regional Planning Commission with the intent of determining if guardrail was required on the northeast corner of the intersection.

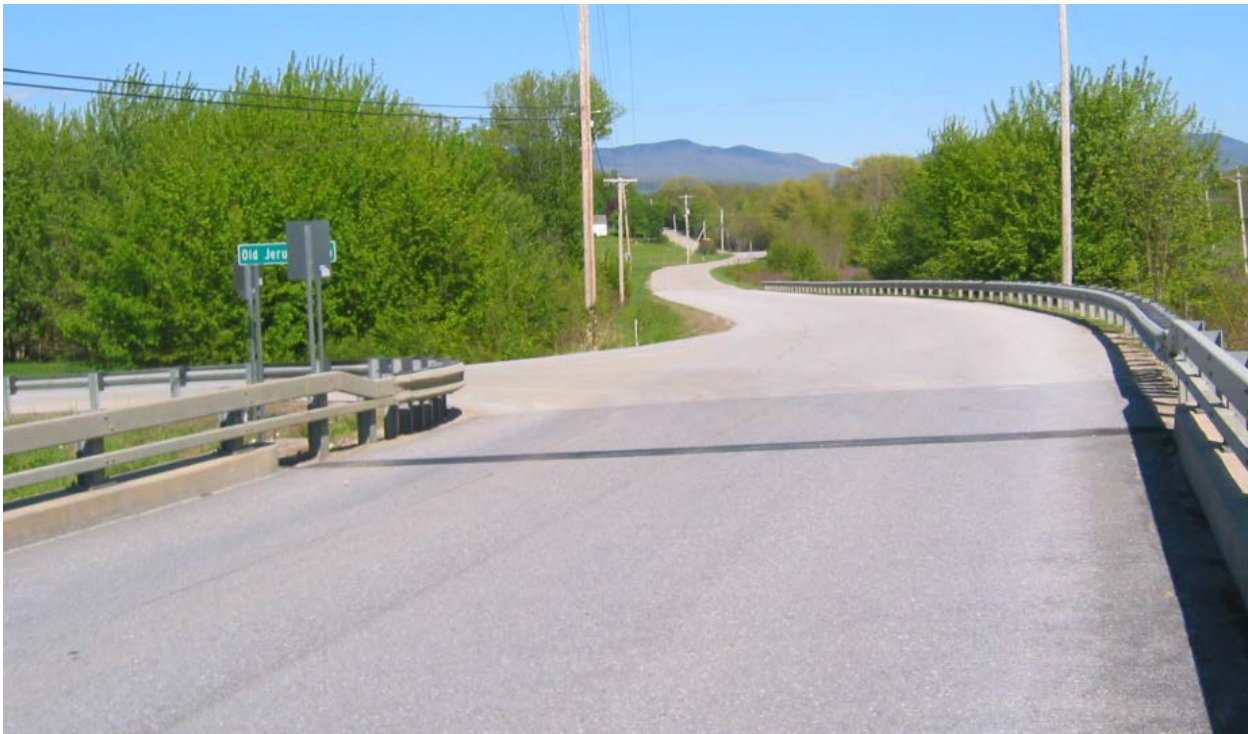
At some point while approaching the Old Jerusalem intersection from the west, the street name sign is partially concealed by the 30 mph speed limit sign.

The street name sign should be reset on longer posts so that it is visible above the speed limit sign.

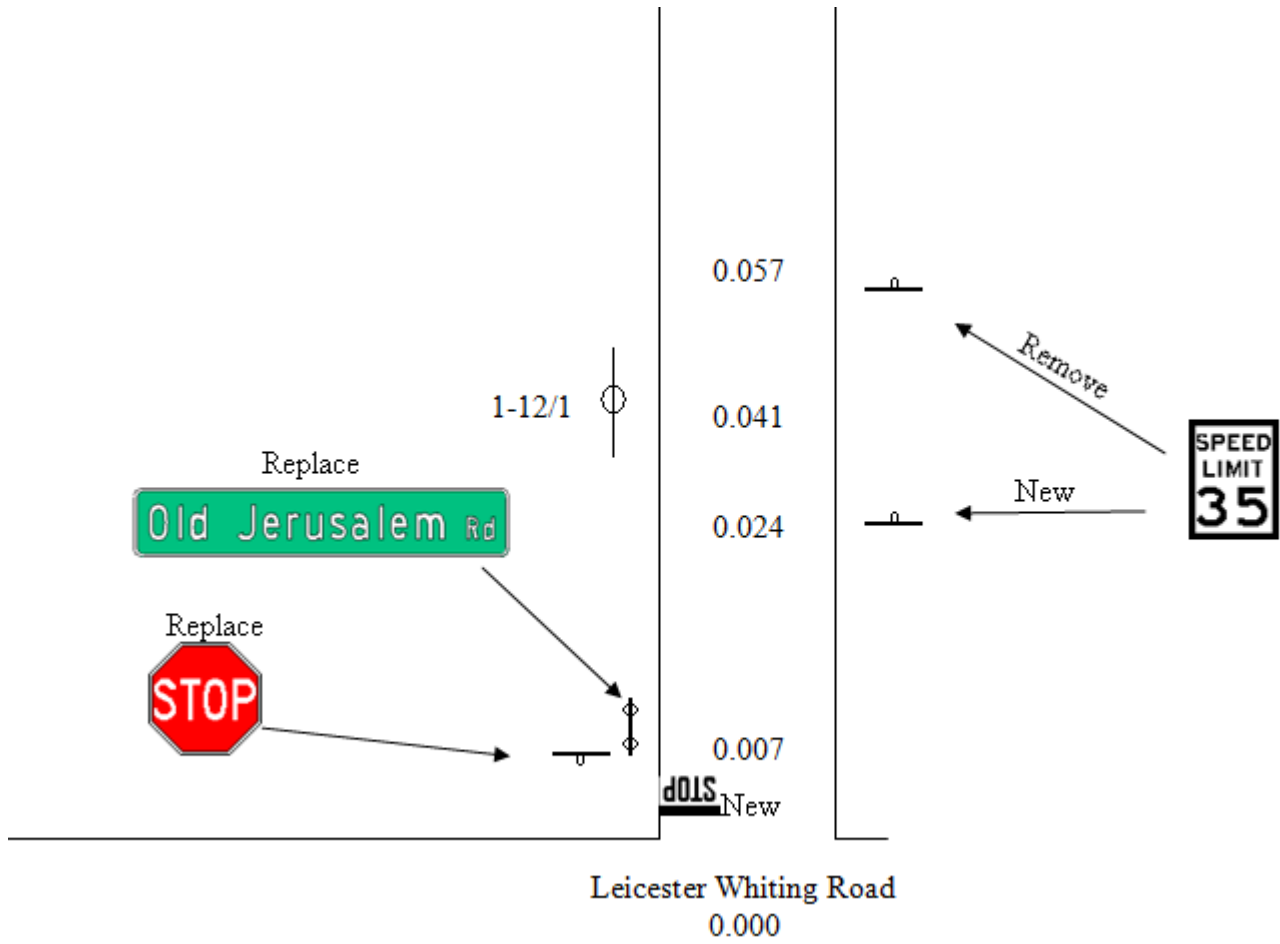
### **HRRR Project Constructed in Spring 2014**

This intersection was part of the High Risk Rural Roads project that was constructed in the spring of 2014. The sketch for the work done in the vicinity of the intersection is available for review in Appendix A.

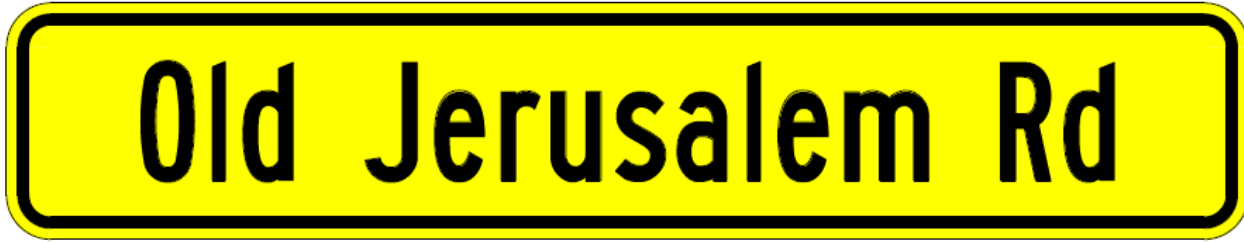
1.50" Radius, 0.38" Border, 0.38" Indent, Black on Yellow;  
 "Old Jerusalem Rd" B 61% spacing;

Install a side road sign with a street name plaque below it for approaching eastbound traffic.
