Appendix G Lowering Speed Limits

RE: Speed Limit Reduction request for VT 22A in Orwell

**Road Safety Audit Review
VT 22 A @ VT 73
Orwell**

VT 22A @ VT 73, Orwell Road Safety Audit Review Review Report

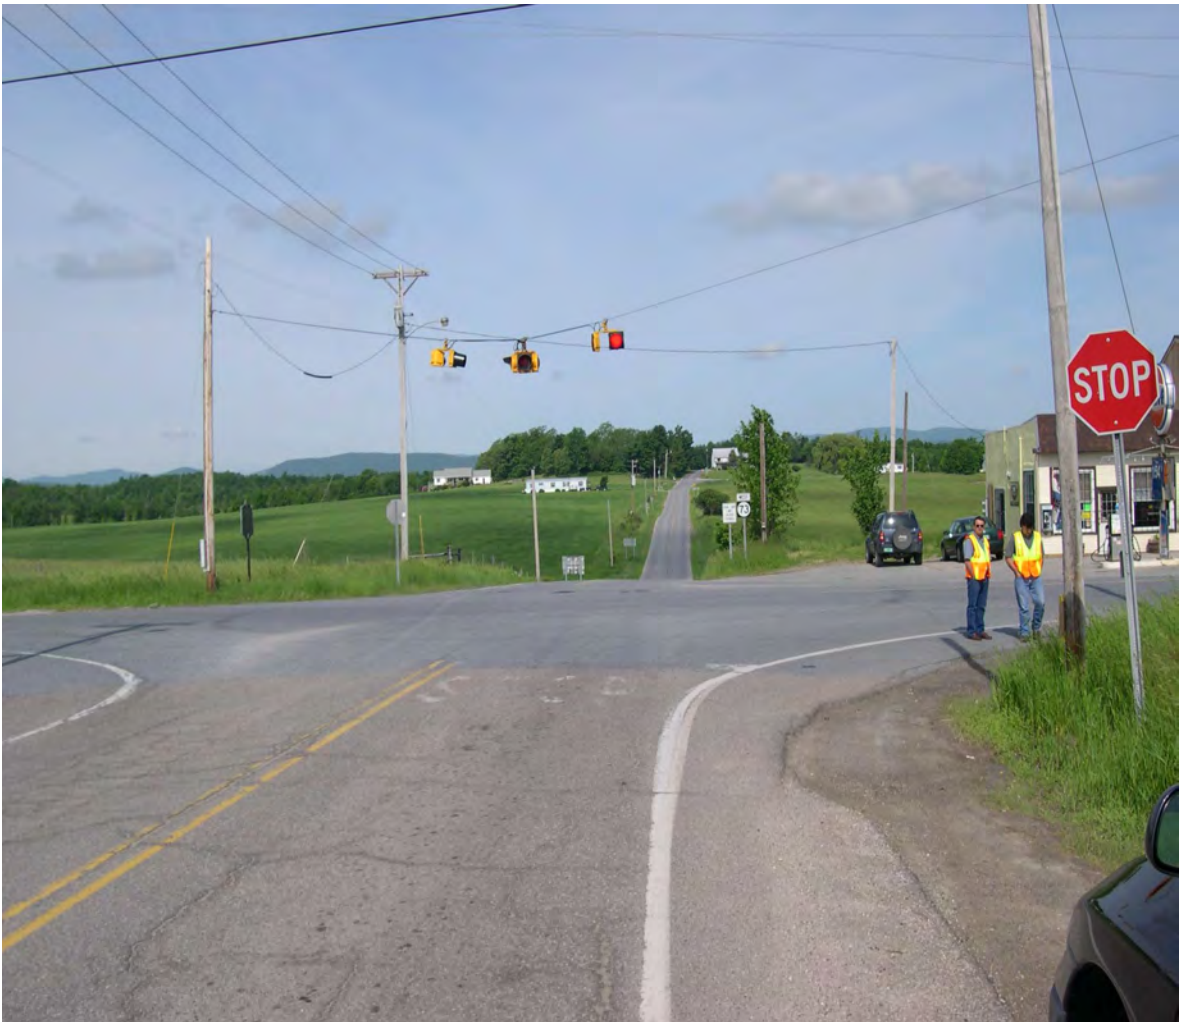
1. The red arrows show the parking problem at the Gulf Gas Station. Installation of a raised island can solve the problem.
2. The blue arrow shows the Stop Bar current condition and the green arrow shows where it should be moved to get better sight distance.
